# CALIFORNIA DIVISION OF MINES AND GEOLOGY FAULT EVALUATION REPORT FER-197

GROUND CRACKS ALONG THE GARLOCK FAULT ZONE IN FREMONT VALLEY, KERN COUNTY, CALIFORNIA

Christopher J. Wills Associate Geologist March 17, 1989

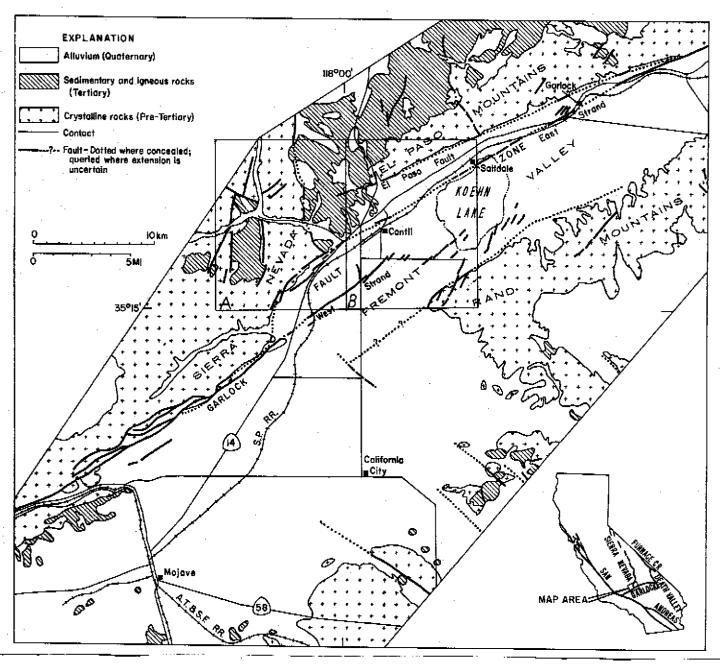
(1952) (Figures 2a and 2b). In Fremont Valley, the fault zone makes a large left step across the deep, alluvial basin (Figure 1). Normal faults, generally with displacements down toward the center of the basin, are distributed across the basin. The pull-apart basin formed by this left step in the fault has been filled in by approximately 3200 m of Cenozoic sediments (Mabey, 1961).

FER 197, Figure 1. Generalized geologic map of the Fremont Valley area from Pampeyan and others (1988) with locations of Cinco (A) and Cantil (B) quadrangles.
